DEPARTMENT OF TRANSPORTATION**DIVISION OF ENGINEERING SERVICES**

Quality Assurance and Source Inspection

Contract #: 04-0120F4Cty: SF/Ala Rte: 80 PM: 13.2/13.9File #: 69.28**WELDING INSPECTION REPORT****Resident Engineer:** Pursell, Gary**Address:** 333 Burma Road**City:** Oakland, CA 94607**Report No:** WIR-015969**Date Inspected:** 25-Jul-2010**Project Name:** SAS Superstructure**OSM Arrival Time:** 1900**Prime Contractor:** American Bridge/Fluor Enterprises, a JV**OSM Departure Time:** 700**Contractor:** Zhenhua Port Machinery Company, Ltd (ZPMC), Changxing Island **Location:** Shanghai, China**CWI Name:** See below**CWI Present:** Yes No**Inspected CWI report:** Yes No N/A**Rod Oven in Use:** Yes No N/A**Electrode to specification:** Yes No N/A**Weld Procedures Followed:** Yes No N/A**Qualified Welders:** Yes No N/A**Verified Joint Fit-up:** Yes No N/A**Approved Drawings:** Yes No N/A**Approved WPS:** Yes No N/A**Delayed / Cancelled:** Yes No N/A**Bridge No:** 34-0006**Component:** Tower and OBG Components**Summary of Items Observed:**

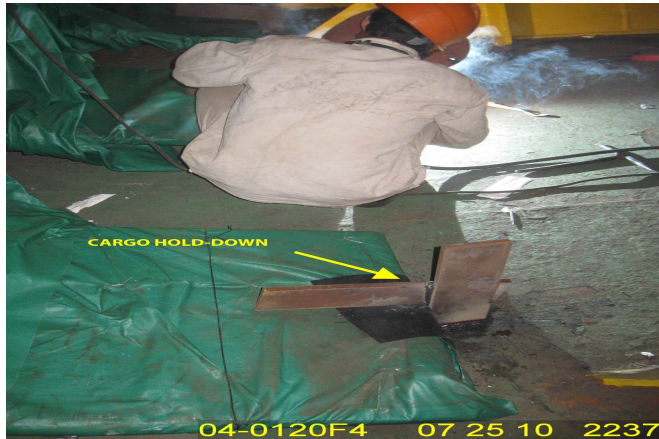
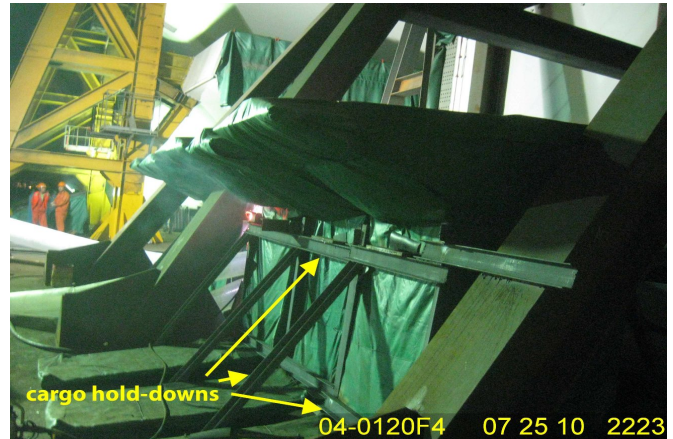
Crossbeams 7, 8, 9, and 10 were positioned on deck on the ship moored to the end of the Heavy Dock, as before. OBG segments 7E, 7W, 8E, and 8W were positioned on deck, forward and aft of the crossbeam sections with segment 7W positioned on top of 7E and segment 8W positioned on top of 8E. ZPMC workers were removing sandblast grit using brushes and vacuums from the bottom plate and side plate areas of OBG segment 8CE, panel

points 67~69 and OBG segments 8AW/8BW, panel points 63~66. ABF personnel were obtaining dry film thickness information in the same area and several ZPMC personnel were performing touch-up painting with rollers. ZPMC welders were attaching plates and shapes to the deck and stanchions to hold down cargo stowed on deck for the upcoming voyage. See photos below.
